## **CONFIDENTIAL INSPECTION REPORT**

1234 Sample Street, Hattiesburg, MS 39402

6/3/2020 9:00am to 10:30am

## SUMMARY REPORT

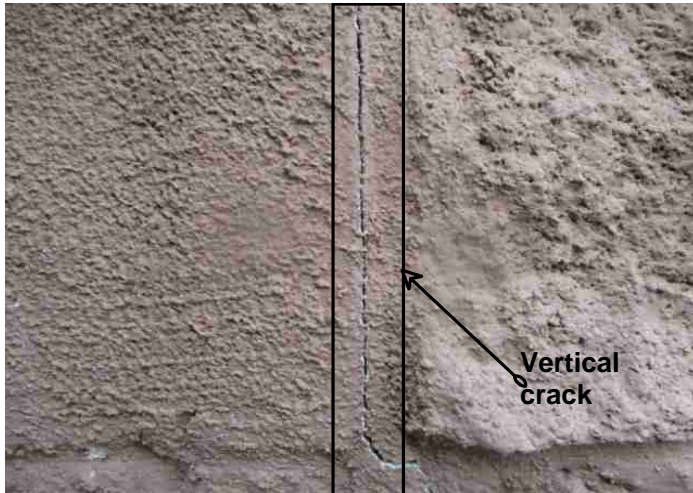
- 3.1 - A narrow vertical crack is present in the concrete block foundation wall at the left-rear. This appears to be a common settlement crack. No evidence of active settling was noted at the time of inspection. Monitoring of this area is recommended.

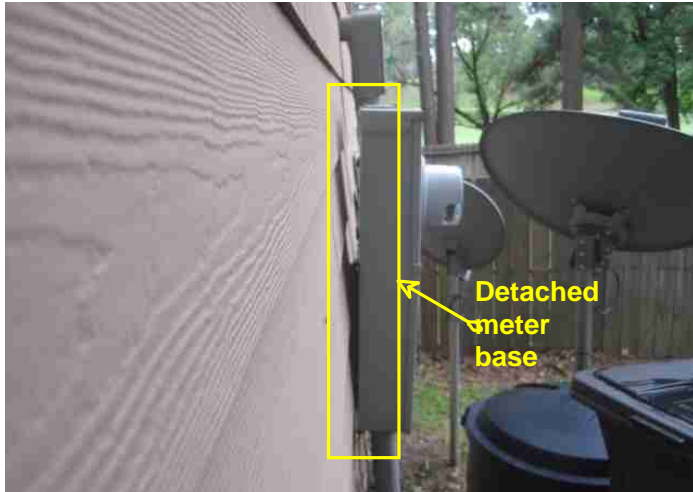
4.6 - The exterior right meter base is detached from the house. Recommend reattaching by a licensed electrician.

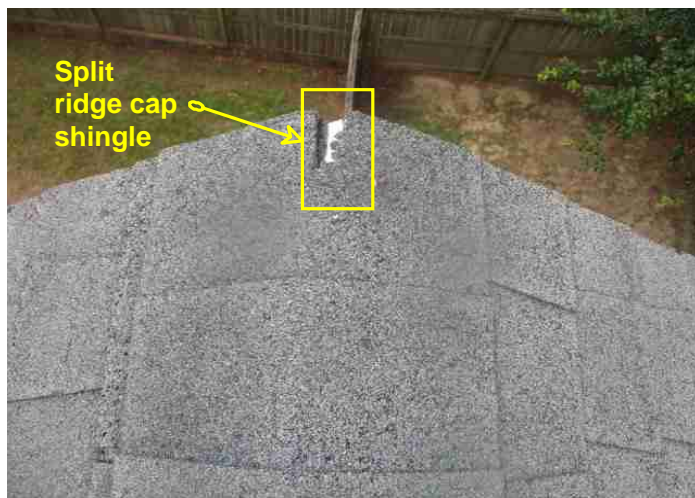
7.1 - A split ridge cap shingle is present at the right gable rake. Recommend further review/repair by a licensed roofer.

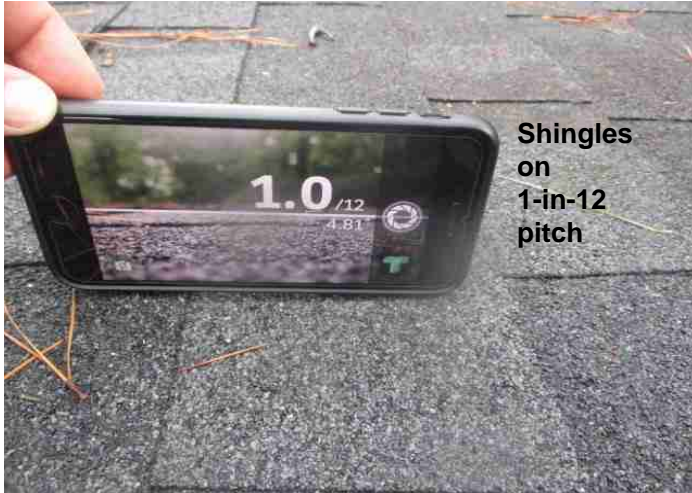
7.3 - The rear patio roof is a low slope roof comprised of architectural shingles on a pitch of 1-in-12. Architectural shingles are not recommended for use on a pitch of less than 3-in-12. No evidence of active leaking was found at the time of inspection. If concerned, the client may pursue further evaluation by a licensed roofer.

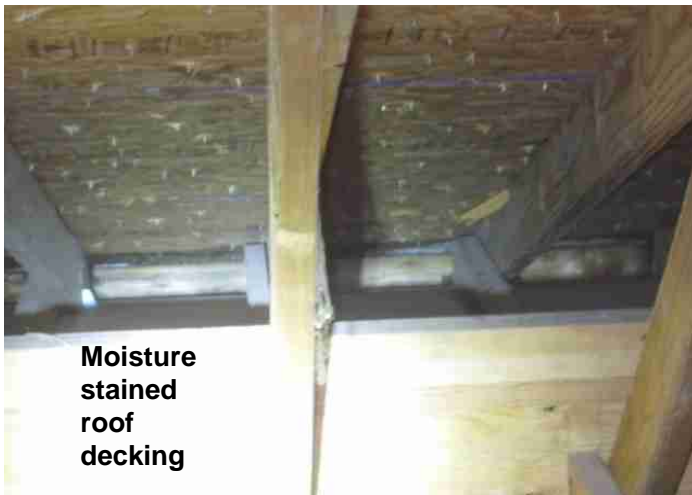
7.4 - Moisture stained roof decking was noted in the attic along the front right eave above the garage. This area tested dry with a moisture meter at the time of inspection. No evidence of active leaking was observed at the time of inspection. Monitoring of this area is recommended.

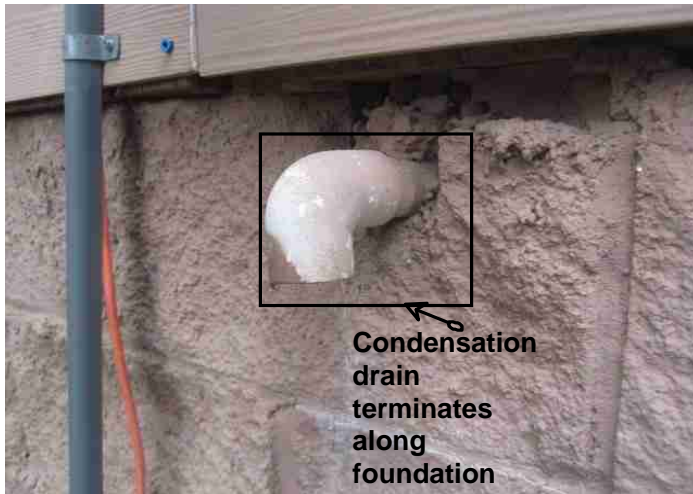
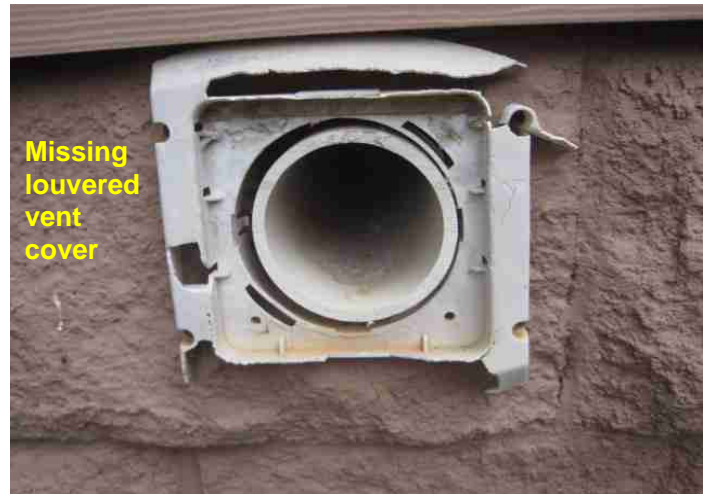
- The kitchen sink faucet leaks below the sink when turned on.
  - The exterior right dryer vent louvered cover is missing. Recommend replacing to prevent pest intrusion.
  - The primary A/C condensation drain terminates in close proximity to the foundation at the exterior right. Recommend extending away from the foundation or re-routing into a plumbing waste line.
  - The hallway bathroom toilet is loose or detached at the anchor bolts/flange.
  - The master bathroom whirlpool tub pump/jets do not operate.
  - The master bathroom tub surround should be re-sealed at the joints along the rim of the tub.
  - The master bathroom sink stopper is missing.
- Recommend review/repair of plumbing service items by a licensed plumber.

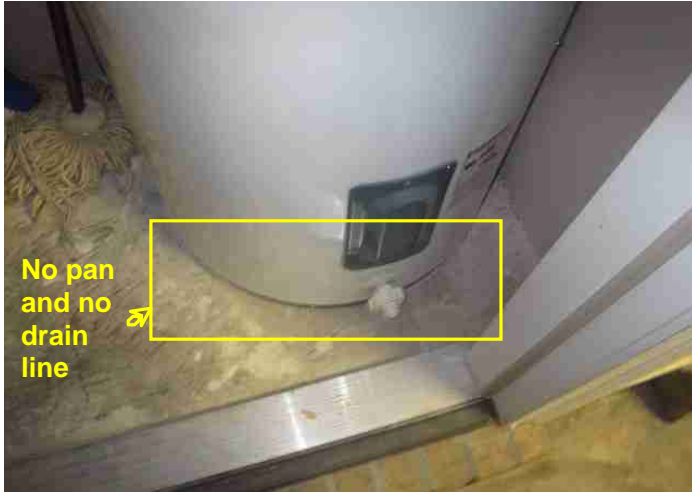
8.5 - The water heater was installed without an overflow pan or drain line. Because the water heater is located on the same slab level as the primary living space, it is recommended that an overflow pan and drain line to the exterior or to a waste line be installed by a qualified specialist.

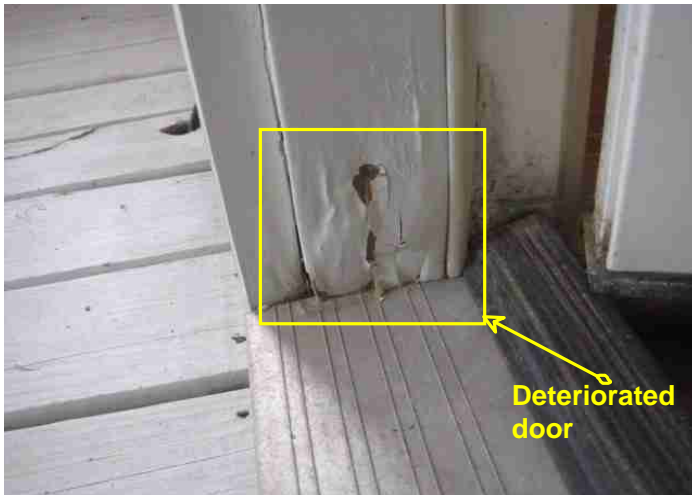
Deteriorated Door - *Continued*

12.4 - The living room/rear patio access door frame is deteriorated at the left and right lower areas. Recommend further review/repair by a qualified specialist.
